PROGRESSIVE COLLAPSE OF STEEL TRUSS BRIDGES, THE CASE OF I-35W COLLAPSE

Abolhassan Astaneh-Asl^a

Abstract: Steel deck truss bridges, being determinate systems and not having redundancy, can progressively collapse over the entire span, if a single primary member or gusset plate connection of the main trusses fails. One of the recent tragic examples of such progressive collapse of the entire bridge due to loss of a single gusset plate is the case of I-35W steel deck truss bridge located in the city of Minneapolis in United States which collapsed entirely on August 1, 2007 resulting in deaths of 13 people and injury to more than 100 others. This paper presents a summary of the structure of the bridge, the condition of the bridge prior to collapse, a likely scenario for its progressive collapse and provides lessons learned and design recommendation in the conclusion section. The recommendations can be used in design of new and in the retrofit of existing steel truss bridges to mitigate this serious life safety hazard.

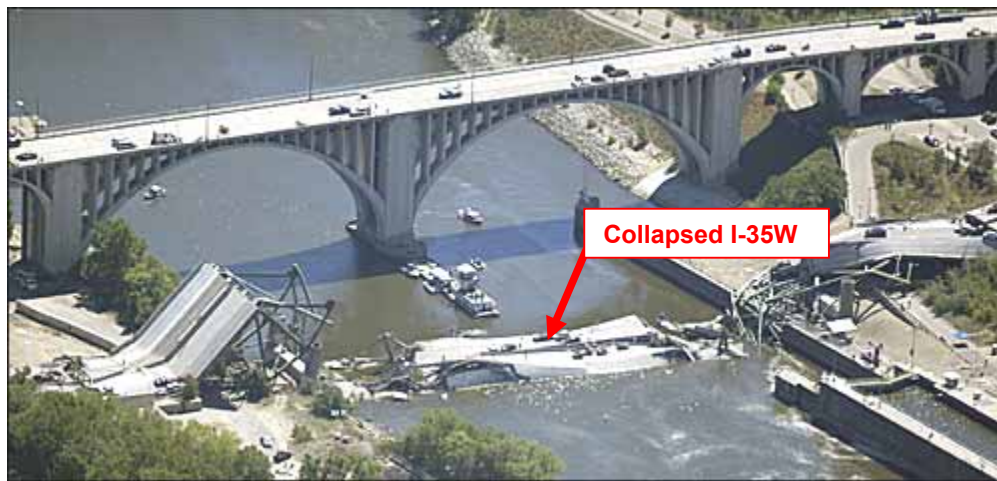
Fig. 2: Views of the collapsed I-35W bridge

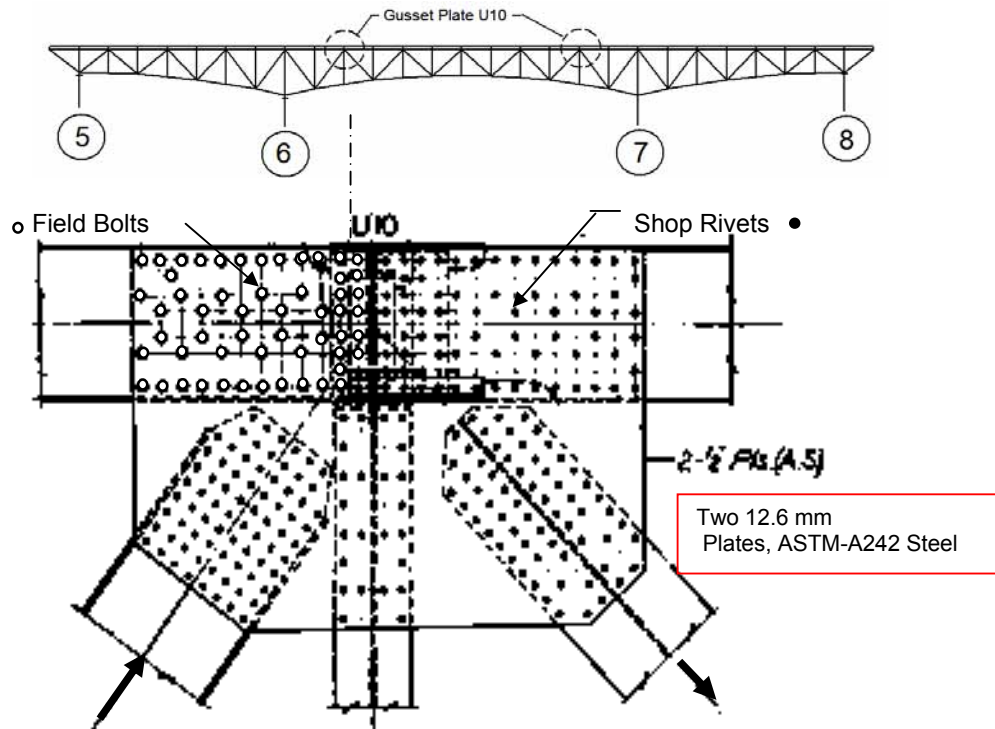
Fig. 4 shows gusset plate U10, which is the gusset plate believed to have fractured first and started progressive collapse of the bridge [astaneh], [NTSB]. The bridge was originally designed by Sverdrup & Parcel in 1965 using AASHTO Specification 1961 [2].

Fig. 4: Details of gusset plate U10 of the I-35W bridge [1]

On August 8, 2007, a week after the collapse the author, while studying the structural drawings of the I-35W bridge posted on the web site of the Minnesota Department of Transportation, [1] discovered that the thickness of gusset plate U10 is only $\frac{1}{2}$ inch (26mm), see Fig.4, much less than what would be needed by design according to the governing specification [2]. He was quoted in the press [3] at the time that:

by the thickness should not exceed 48 for the type of steel used in gusset plates of this bridge. In gusset plates U10 of the I-35W Bridge the ratio of free length of gusset plate exceeded 60, far more than 48 allowed.

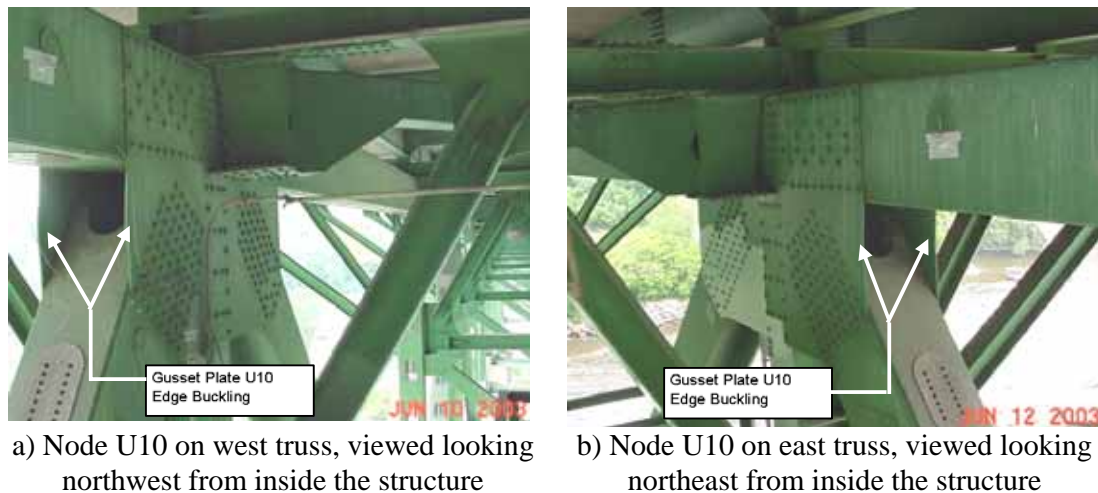
Photographs taken in 2003 of the bridge, Fig. 5, show that gusset plate U10 had already developed edge buckling failure mode during or prior to 2003, four years before the bridge collapsed in 2007. The edge buckling of gusset plate U10, shown in Fig. 5, is on the compression side of the gusset plate.

Fig. 5: Edge buckling of gusset plate U10 of the I-35W bridge photographed in 2003 [4]

Although edge buckling of gusset plate itself is not expected to result in progressive collapse of entire span, when it occurs in a gusset plate, it is a definite sign of over-stressing of the gusset plate. In addition, when the edges of compression side of gusset plate buckle, the buckled areas can no longer support additional load. Also, since the edge buckling is usually elastic buckling, the buckled area cannot maintain the buckling capacity. As a result, the stresses that were carried by the compression zone of gusset plate prior to buckling, will be redistributed to other areas of the gusset plate such as the tension areas. The additional load applied to the gusset also is carried by the tension zones and areas that have not buckled, further increasing tensile stresses in the gusset plate. When these increased stresses reach the capacity of net section of the gusset, which in these gusset plates with large number of rivet holes is the governing failure cross section, the net section fractures and the progressive collapse of the determinate truss starts.

It appears that, since gusset plates U-10 had already buckled at the time of the URS study [7], and the fact that gusset plate U-10 is located right at the top of permanent ladder shaft of the bridge, a cursory inspection of the gusset plate U-10 would have revealed that the gusset plate had failed and buckled, Fig. 5. Such failure would have been reported to the MN-DOT, the bridge owner, with recommendations for mitigating the danger of collapse, and the catastrophe would have been avoided.

In design of new gusset plates and evaluation of condition of existing gusset plates, it is necessary that this failure mode is investigated and if it was governing, stiffeners in the form of angles (usually) or plates be added to the edge of gusset plates to prevent the edge buckling such as shown in Fig. 5. The AASHTO Specification-1961 [2], which was the design code for this bridge, has a provision stating that the ratio of free length of the gusset plate edge divided

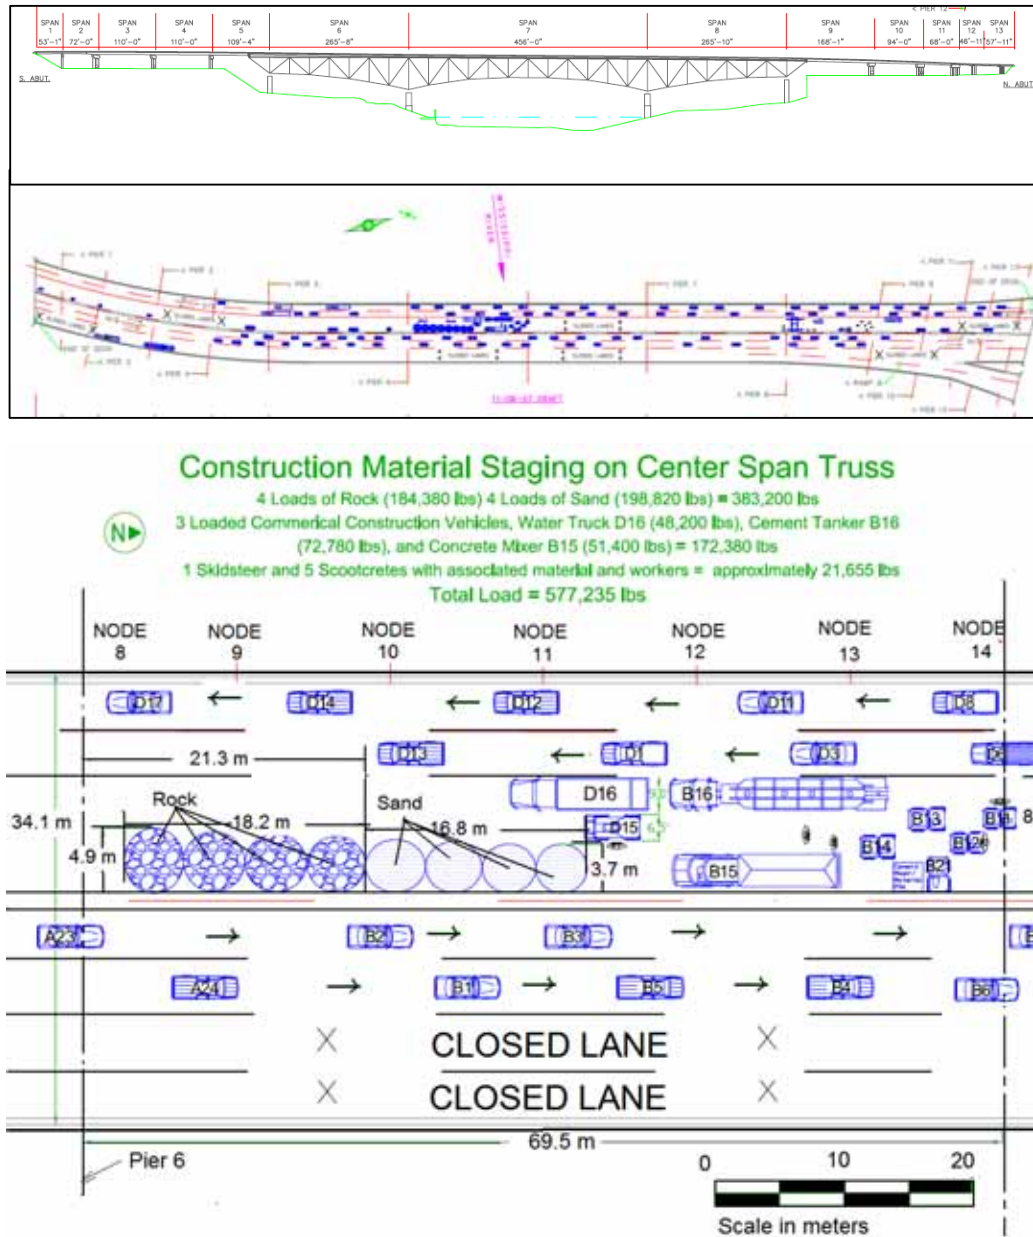
For several months prior to the collapse, the I-35W bridge was undergoing repair and replacement construction activities on its deck. According to construction contract documents [1], the construction activity on the bridge in the months leading to the collapse consisted of removing the top 5 cm wearing surface concrete as well as cutting about 100cm of the entire deck slab at location of the expansion joints and replacing the expansion joints as well as the removed part of the deck. Fig. 6 shows the traffic and construction equipment on the bridge on the day of the collapse. The drawings are from NTSB publication [4] and were prepared using aerial photographs taken by a passenger in a plane flying over the bridge a few hours before the bridge collapsed. The construction load on the bridge was extra-ordinarily heavy. According to the NTSB report [4], as indicated in Fig. 6, the total weight of construction material and equipment on the deck just above the gusset plates U10 or near them was about 2600 kN. Apparently in order to do the deck and expansion joint repairs, the staging area for construction was selected to be on the bridge itself.

Fig. 6: Construction loads on the bridge according to a NTSB report [4]

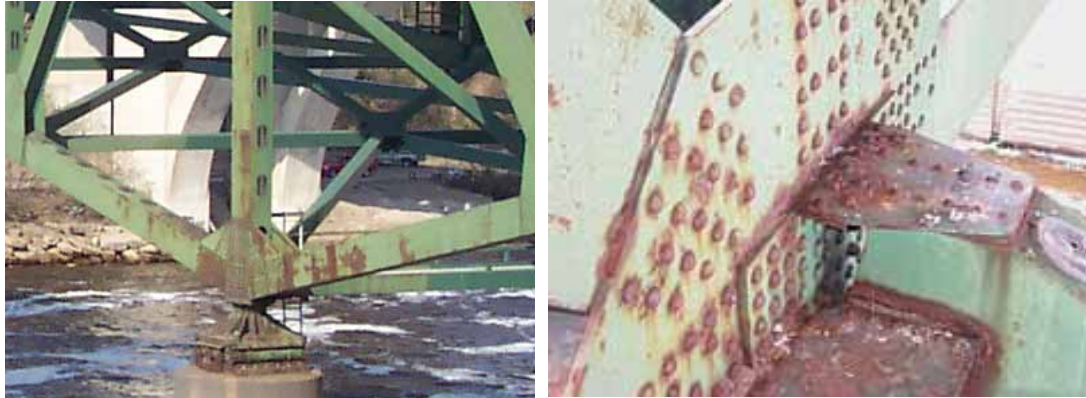
A study of the inspection reports prepared by the Minnesota Department of Transportation, the owner and maintainer of the bridge, as well as photographs taken in the past, indicated that the I-35W Bridge had previous corrosion problems in the main river crossing, see Fig.

7(a). Inspection reports issued by the Minnesota Department of Transportation show the presence of corrosion on some gusset plates and adjacent areas, Fig. 7(b), indicating that due to corrosion, some gusset plates and even some members may have thinned over the years and did not have the originally designed thicknesses at the time of collapse.

a) corrosion of roller bearing

b) corrosion in the gusset plate areas

Fig. 7: Corrosion in the roller support at Pier 6 and gusset plate area, I-35W bridge
(dates and photographers unknown)

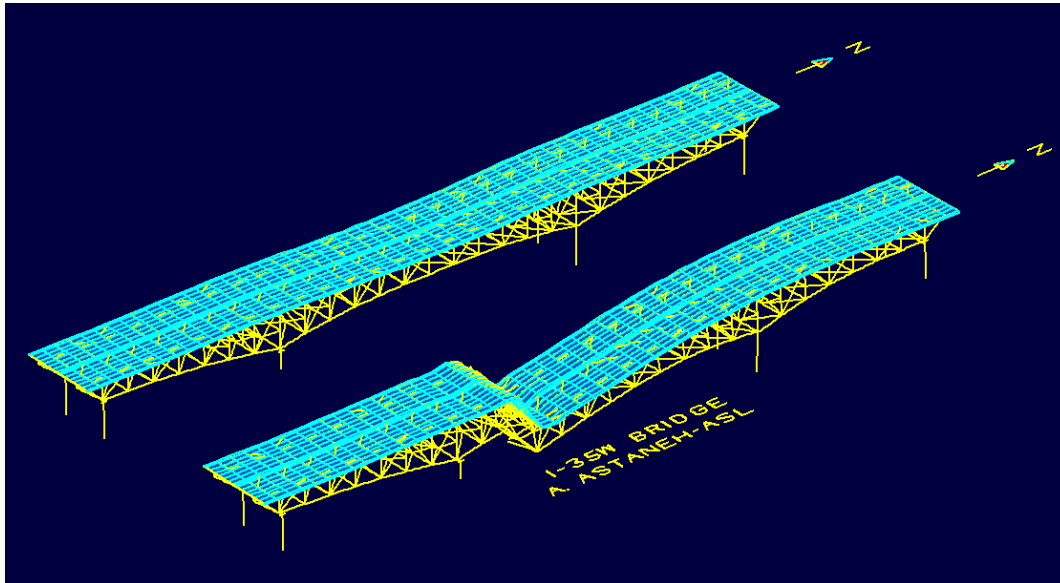
Fig. 8 shows the 3D elastic model of the bridge which predicts the initiation of progressive collapse after fracture of gusset plate U10. At this time, we are in the process of building Perform and Nastran models.

Fig. 8: The I-35W bridge collapse initiation predicted by SAP2000 []
