# PROGRESSIVE COLLAPSE RESISTANCE OF STEEL BUILDING FLOORS

REPORT NUMBER: UCB/CEE-STEEL-2001/03  
DEPARTMENT OF CIVIL AND ENVIRONMENTAL ENGINEERING  
COLLEGE OF ENGINEERING  
UNIVERSITY OF CALIFORNIA AT BERKELEY

# FLOOR CATENARY ACTION TO PREVENT PROGRESSIVE COLLAPSE OF STEEL STRUCTURES

Report to the American Institute of Steel Construction

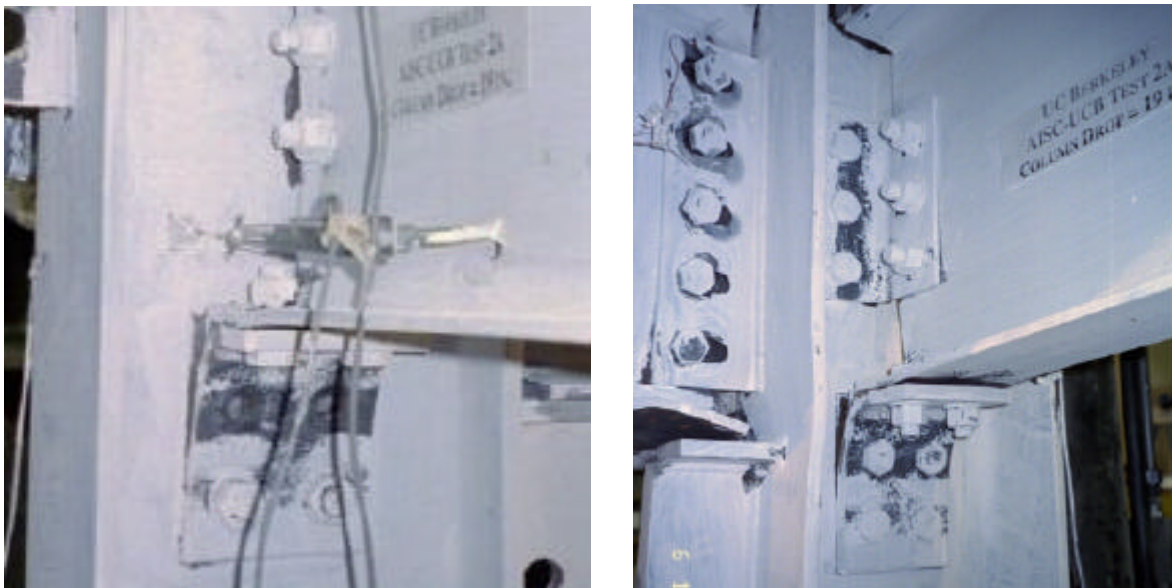
As the column displacement exceeded 14 inches, failure occurred of the top two bolts on the lower leg of the seat angle that holds the longitudinal beams. This is identified as spike “A” in both the force time history and force displacement plots in Figure 3.1. The end of the bolts, including the nuts, violently shot through the air while the head of the bolts remained in place. A total of four bolts held the angle to the displacing column, leaving only two bolts to resist the vertical load of the beams. As the bolts were failing, the seated angle itself was undergoing local yielding and deformation. See Figure 3.2 for a photograph of the local damage.

Figure 3.2. Failure of Top Two Bolts in the Seat Angle

1. Connection bolts should be strengthened to improve structure behavior in a loss of column scenario. The bolt failures observed in the experiments led to greater specimen deformations and resulted in failure of a beam-to-column angle connection. High-strength bolts and/or larger sized bolts would improve the behavior of the system with little additional cost.

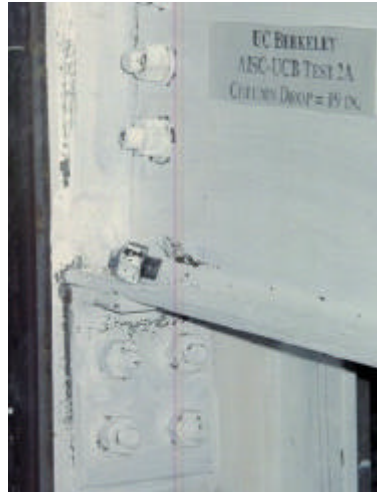
As the displacement approached 15 inches, at the other end of one of the longitudinal beams, west of the displaced column, the two bolts that secured the beam to the top of the seated angle also failed and “popped” (Figure 3.3). Spike “B” in Figure 3.1 clearly shows the loss of strength as a result of the bolt failures. The shear tab that supports the transverse beam also underwent local yielding.

Figure 3.3. Failure of the Two Bolts on the Seat Angle

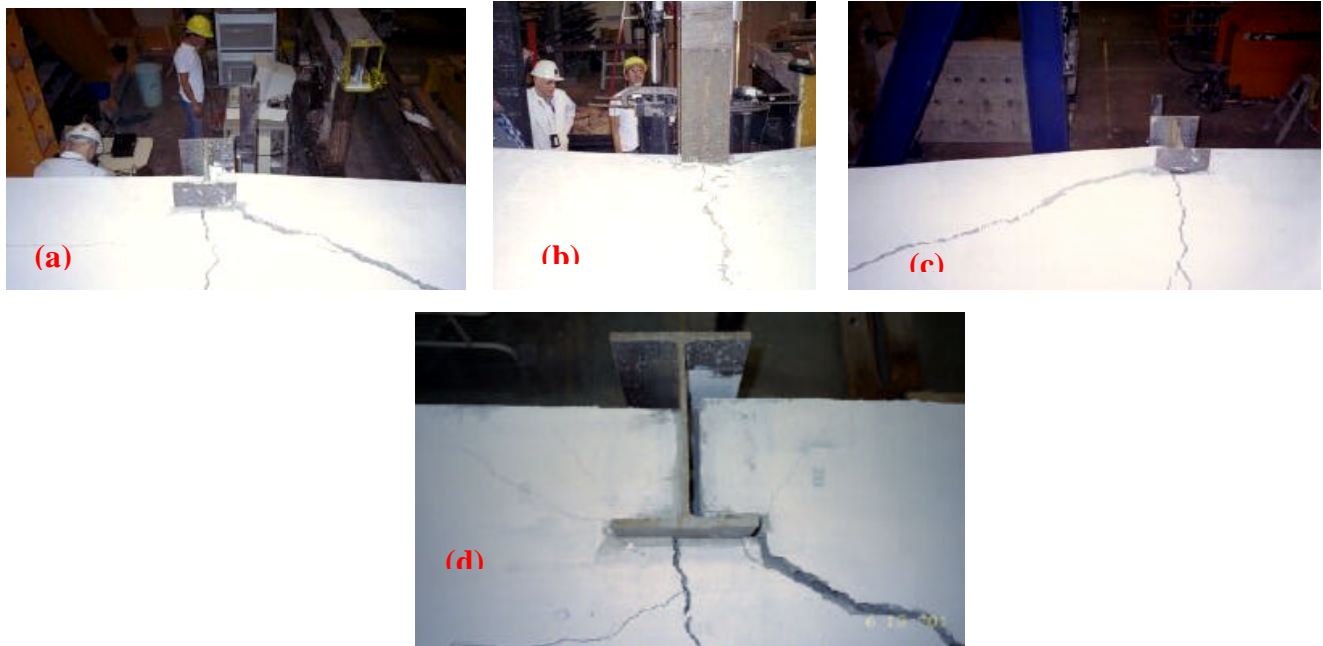
The concrete slab separated from certain columns as the displacement increased. At the final displacement of 19 inches, a gap of approximately 1 inch had opened between the slab and column B2. Photographs of the local damage surrounding columns B2, C2 and D2 are included as Figures 3.4(a), 3.4(b) and 3.4(c) respectively. Figure 3.4(d) shows close-up of the cracks around column B2.

Figure 3.4. Cracking of the Concrete Slab at Column B2 at the End of 19-inch Drop Test

2. Placing reinforcement bars within the concrete slab could postpone and possibly eliminate complete cracking of the slab. The bars could be placed along the column lines of any frames susceptible to blast loads. The additional steel cross section should prevent complete shear fracturing of the floor slab.

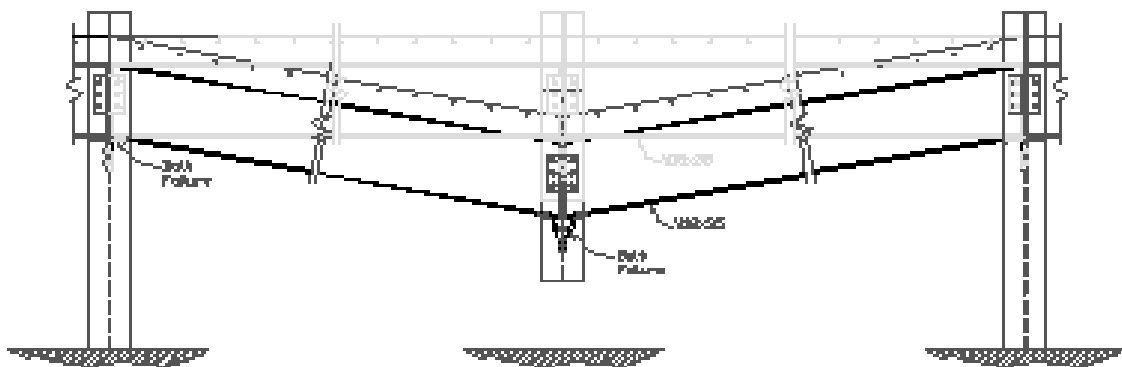
Figure 3.5. A Sketch and Views of Specimen at the End of 19-inch Drop Test

A sketch of specimen at the end of 19-inch drop test is shown in Figure 3.5. The most notable behavior observed in the 19-inch displacement was the failure of two sets of bolts. The first to fail, located at the seated connection of the displacing column, revealed the limited rotational flexibility of the beam-to-column connections. The bolts failed when the longitudinal beam rotated  $3.2^\circ$  relative to the displaced column. Immediately following, the bolts failed at the other end of the beam directly west of the displacing column. This second set of bolts connected the longitudinal beam to the seated connection. Although these bolts do not provide any direct vertical load carrying capability, the catenary action of the displacing frame is lost.

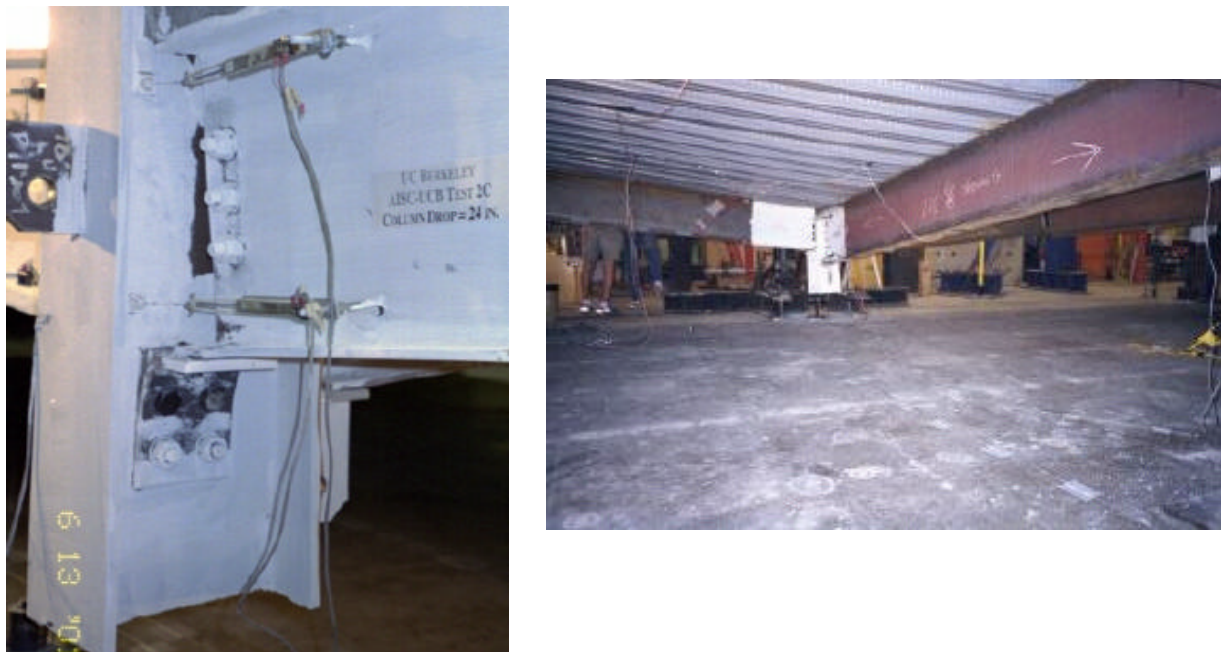
As the column reached a displacement of approximately 19 inches, the two bolts that held the longitudinal beam, east of the loaded column, on the seated connection at column C2 failed (Figure 3.7). The dramatic drop in load is evident as spike “D” in Figure 3.6. Local yielding of the seated connection could also be observed. Also, cracking and tearing of the connecting angle between the loaded column and the longitudinal beam directly east had begun.

As a result of the two bolt failures, large eccentricities were created as the east actuator shot back to zero load while the west actuator was still providing 20 kips of load to provide the constant displacement. At a displacement of 24 inches, the west actuator was applying approximately 45 kips of downward force while the east actuator was applying approximately 10 kips of upward force.

Figure 3.7. The Two Bolts on The Seat Angle Were no Longer Present

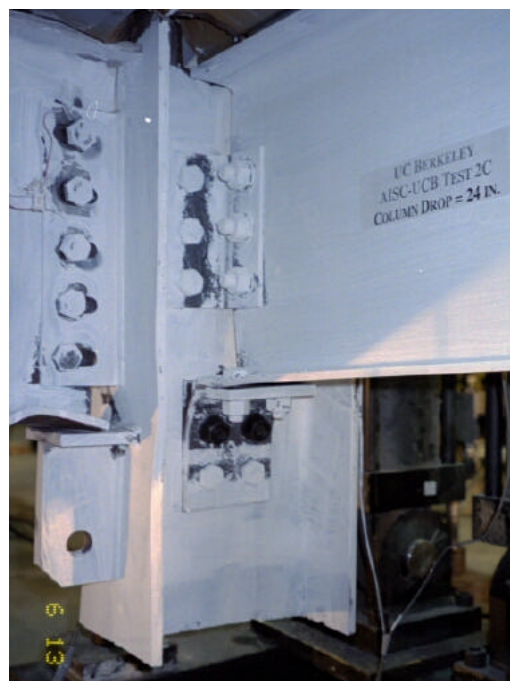
While attempting to replace the same top two bolts on the seated angle connection that were replaced before, it was noticed that the bolts did not fail, but underwent large deformations. The bolts were removed, but could not be replaced with new bolts due to the large deformations.

Figure 3.8. The Two Replaced Bolts on the Top Half of the Bottom Leg of the Seat Angle Remained in Place.

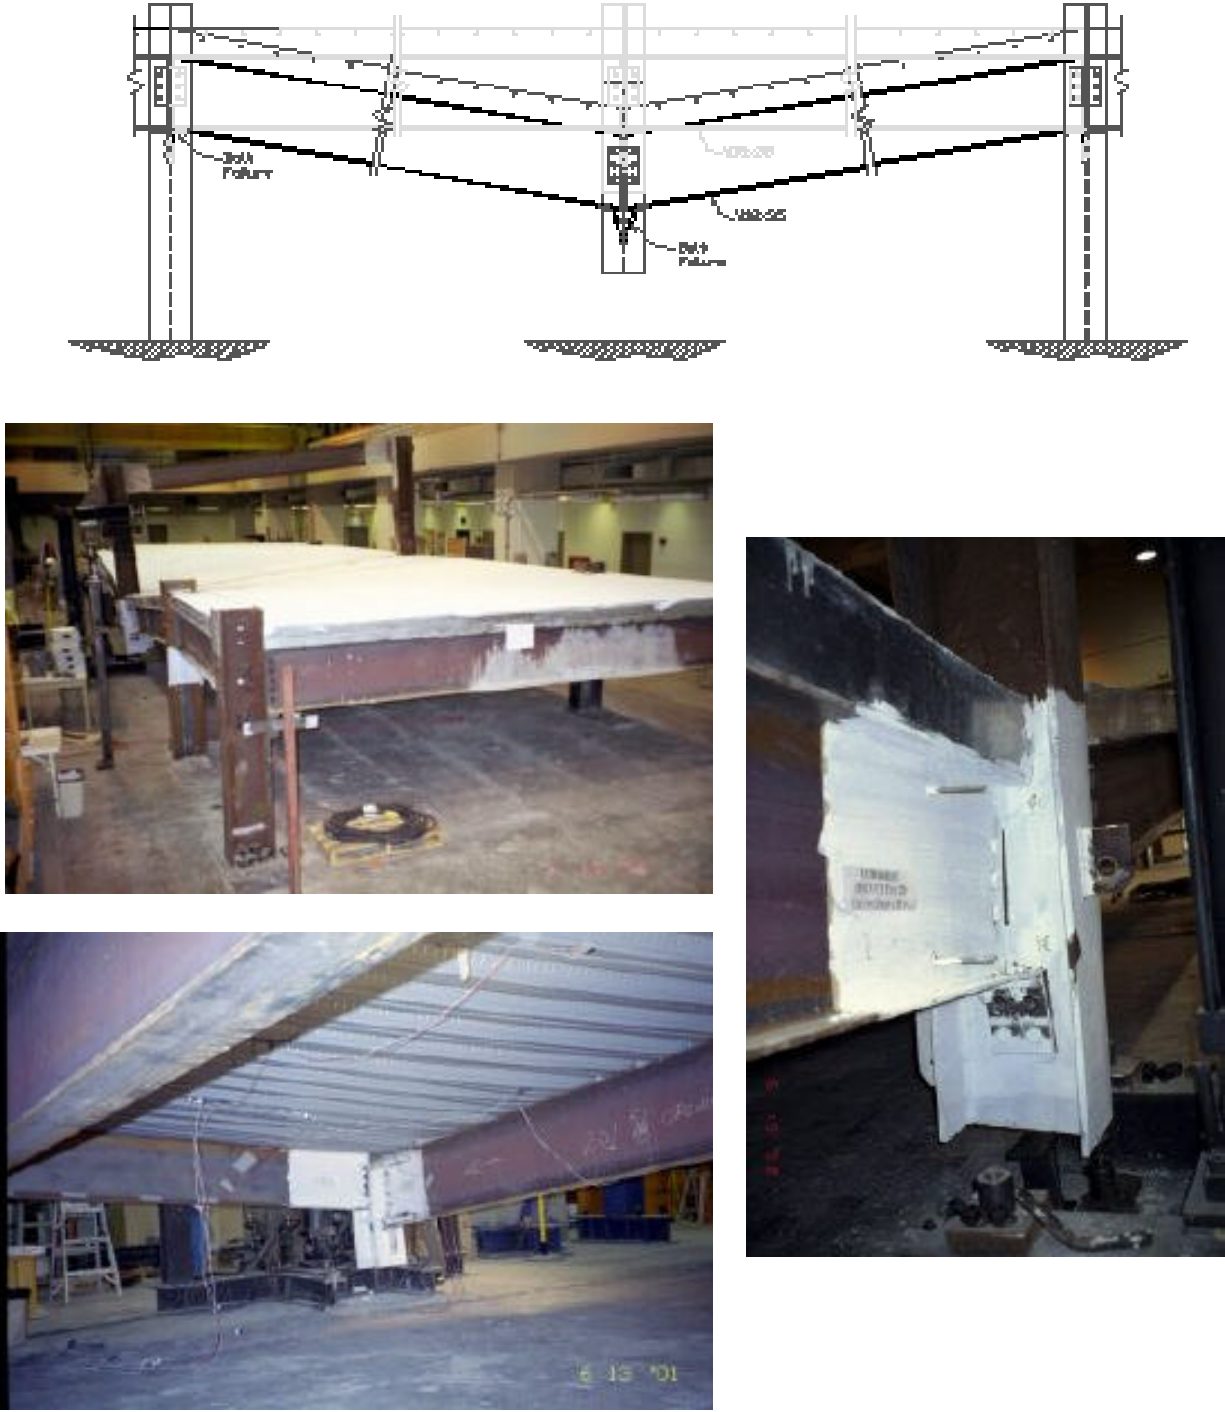
A sketch of specimen at the end of 24-inch drop test is shown in Figure 3.9. Only one failure occurred during the column displacement to 24 inches. The pair of bolts failed that secured the longitudinal beam directly east of the displaced column to the seated connection. Unlike the beam west of the column, this failure occurred at the end connecting into the test column. Both failures left the bottom flanges of the beams free to move at one end. As a result of the asymmetrical failure, the structure was no longer behaving in a symmetrical manner. The east actuator was actually applying a 10 kip upward force to the column even though the column

was being displaced downward. Strengthening the bolts to eliminate their failure should produce a more balanced, well-behaved failure mechanism.

Figure 3.9. A Sketch and Views of Specimen at the End of 24-inch Drop Test

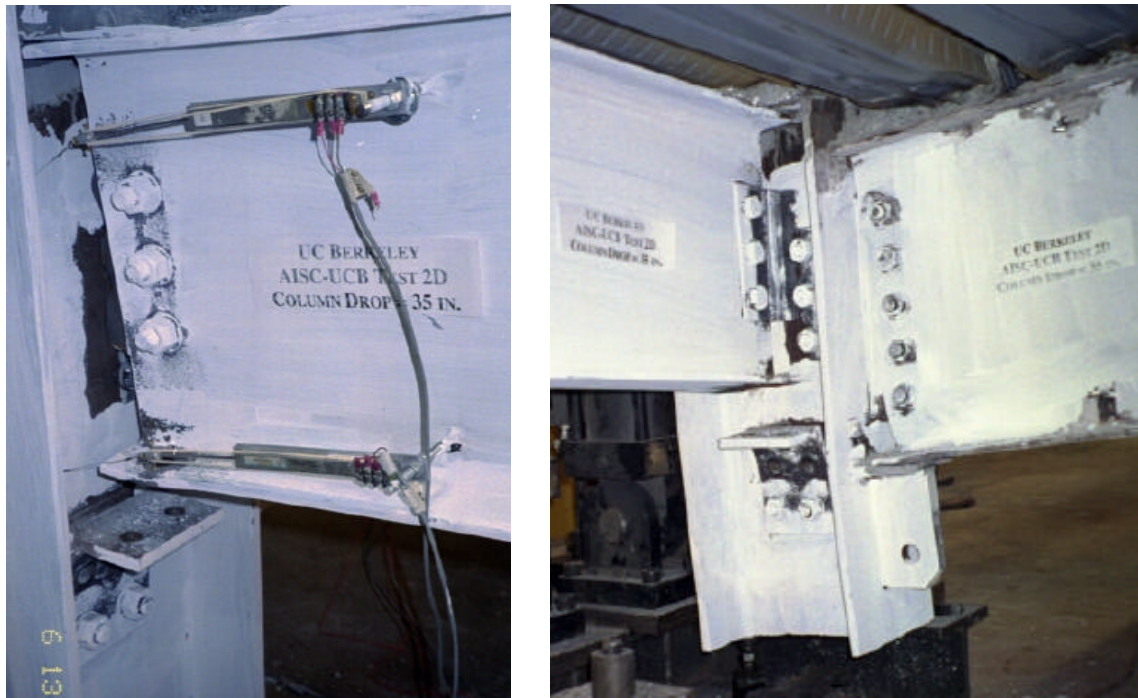
In addition to the above noted behavior, as the column displacement approached 26 inches, complete failure occurred of the connecting angle between the loaded column and the longitudinal beam directly east (Figure 3.10). Spike “F” in Figure 3.8 shows the sudden drop in load after the angle failure. The preceding spike, labeled “E,” is evidence of slippage within the structure, possibly within the angle before complete failure.

After the angle had failed, the concrete slab was the primary element transferring the applied force to the longitudinal beam directly east of the displacing column. Unable to maintain this force transfer, the slab failed in shear along the transverse beam connecting the two central columns. This is represented by spike “G” in Figure 3.10.

Figure 3.11. Complete Failure of the Shear Angle on the Web of Column

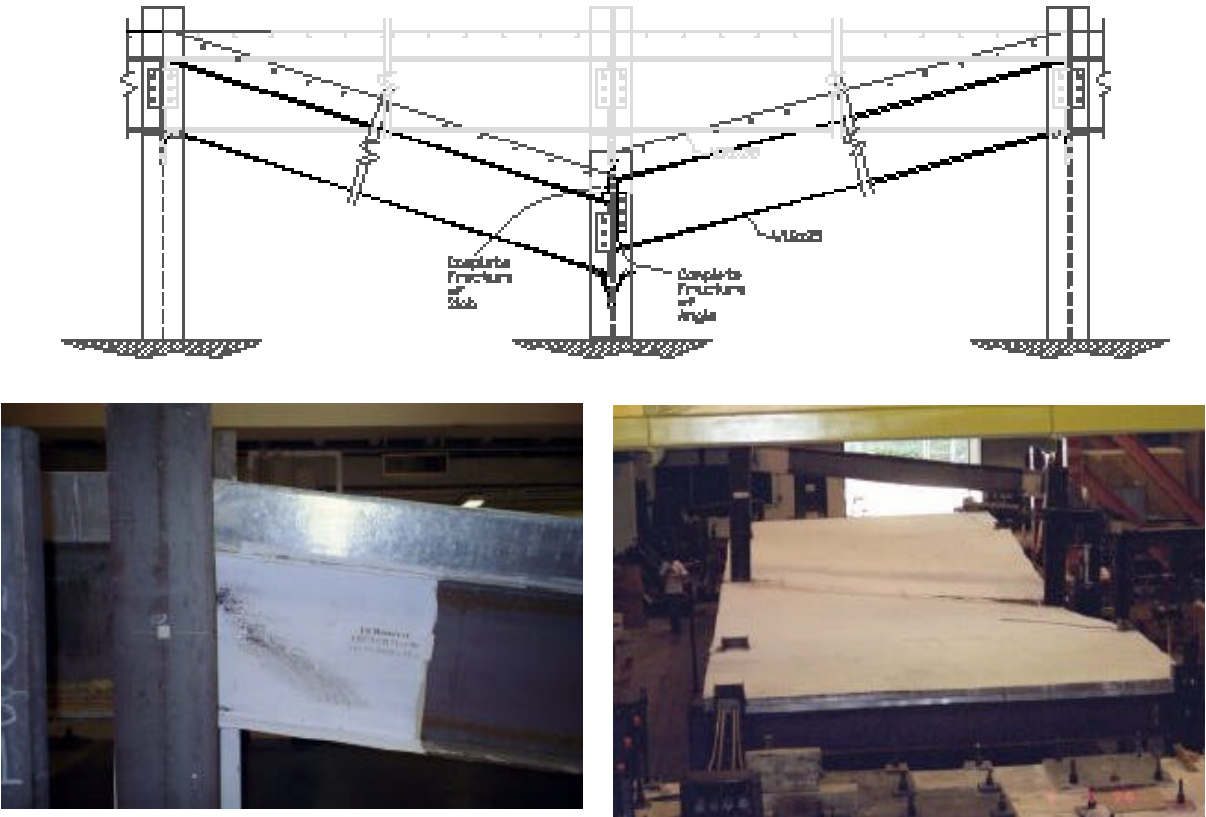
The concrete slab and steel deck suffered great damage during the 35-inch displacement. The steel deck continued to tear, opening up gaps both within and between deck segments. The damage was concentrated along the column line of the tested column. There was a separation of at least one inch between deck segments along the transverse beam connecting the two center columns. Near column D2, the deck tore, opening up a hole that measured over three inches between the steel deck and concrete slab.

Figure 3.12. A Sketch and Views of Specimen at the End of 35-inch Drop Test

In addition to the above noted failures, two additional component failures occurred during the 35-inch displacement. First, failure occurred of the connecting angle between the test column and the longitudinal beam directly east. The concrete slab was left as the only remaining component to transfer the applied force of the actuators to the east side of the structure. Unable to provide this force transfer, the concrete slab failed in shear.
