PROGRESSIVE COLLAPSE OF STEEL TRUSS BRIDGES, THE CASE OF I-35W COLLAPSE

Abolhassan Astaneh-Asl^a

Abstract: Steel deck truss bridges, being determinate systems and not having redundancy, can progressively collapse over the entire span, if a single primary member or gusset plate connection of the main trusses fails. One of the recent tragic examples of such progressive collapse of the entire bridge due to loss of a single gusset plate is the case of I-35W steel deck truss bridge located in the city of Minneapolis in United States which collapsed entirely on August 1, 2007 resulting in deaths of 13 people and injury to more than 100 others. This paper presents a summary of the structure of the bridge, the condition of the bridge prior to collapse, a likely scenario for its progressive collapse and provides lessons learned and design recommendation in the conclusion section. The recommendations can be used in design of new and in the retrofit of existing steel truss bridges to mitigate this serious life safety hazard.

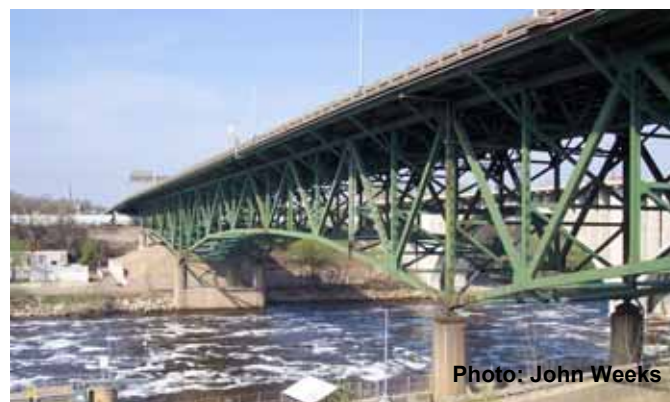
Fig. 1: A view of the I-35W bridge looking northeast

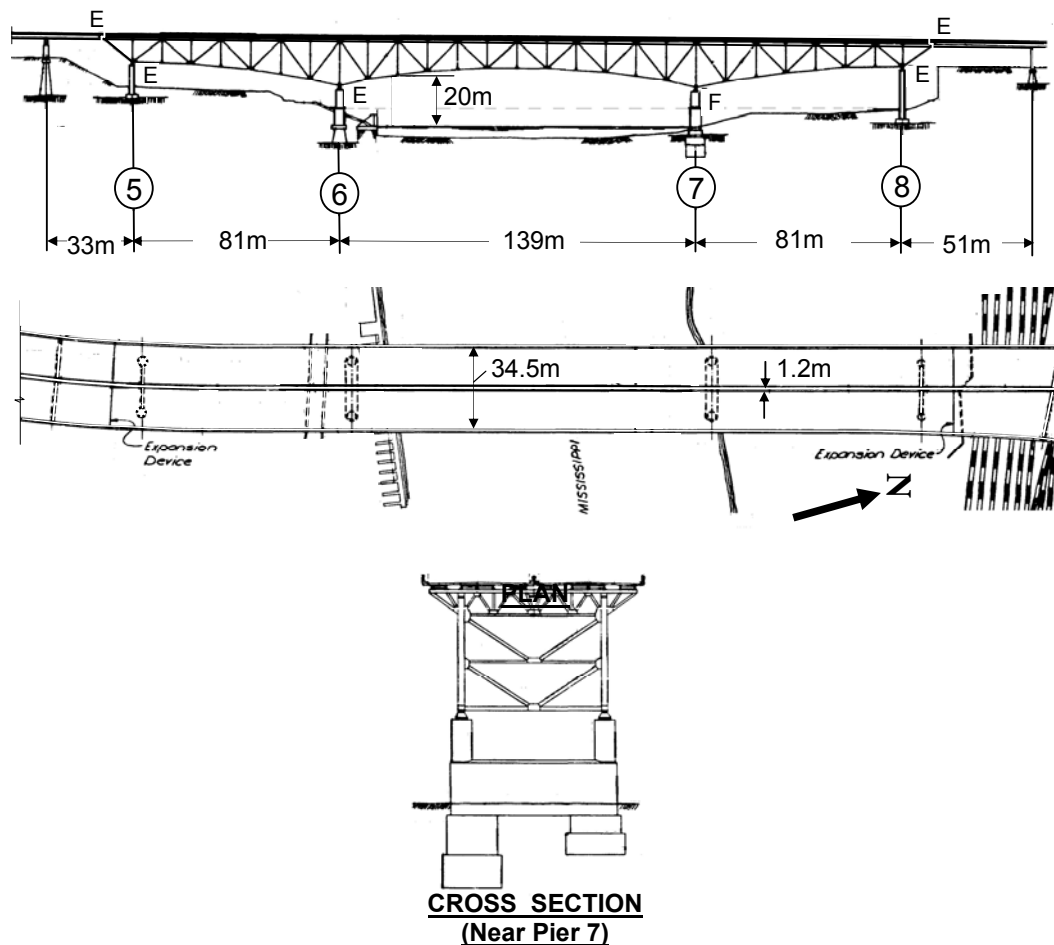
Fig. 3 shows the structure of the I-35W Bridge [1]. The superstructure of the bridge consisted of two main longitudinal trusses continuous over three spans of 81m, 139m and 81m. The two longitudinal trusses were connected to each other with transverse trusses at each panel point, Fig. 3. The transverse trusses were cantilevered out on both east and west side of the bridge with each cantilever providing one lane of traffic. There were eight lanes of traffic on the bridge with 6 lanes between the main trusses and two lanes, one on each cantilever. The transverse trusses supported floor longitudinal stringers, which in turn were supporting the reinforced concrete deck of the bridge.

Fig. 3: Structure of the I-35W bridge [1]
